Report: 3640Sample **Address:** 123 Main Street

Confidential Inspection Report
123 Main Street
Omaha, NE 68132

Prepared for: Sample

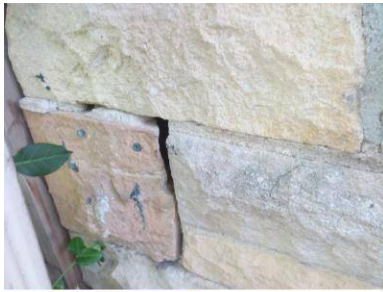
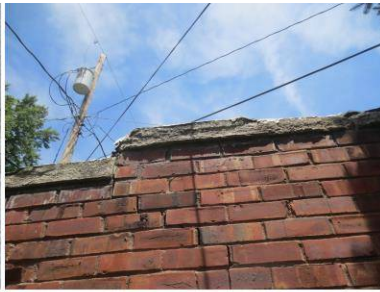
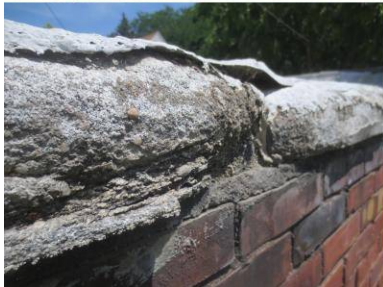
The brick/mortar had various areas of cracking/loose brick/mortar. This was noted at southeast corner and various areas in the back west. Suggest a qualified contractor review and/or repair all damaged siding.

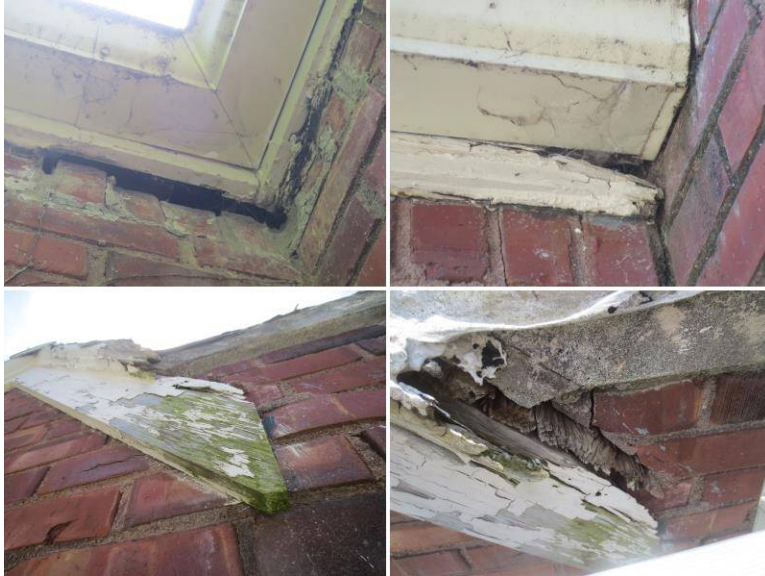
Wood-type material. Rot/deterioration noted in various areas on trim/soffits. Suggest a qualified contractor review and repair all damaged areas.

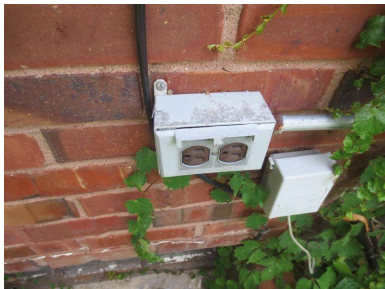
Electrical outlet(s) are not GFCI protected on exterior of this home . Although GFCI outlets may not have been required at the time this home was built, today code does require all outlets to be GFCI protected on the exterior of homes. Suggest upgrading to GFCI outlets to ensure safety. The back west outlet needs a proper exterior rated outlet cover. Suggest a licensed electrician review/repair to ensure maximum safety.

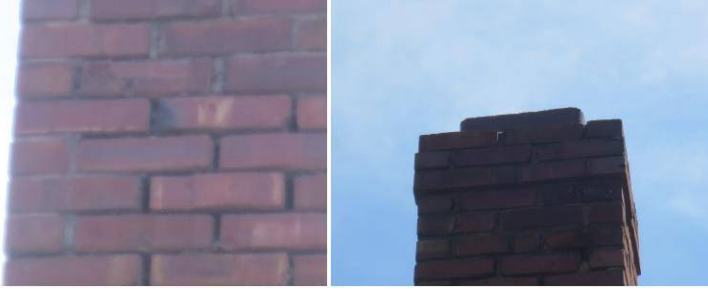
No spark arrester/rain cap installed. These may not have been required when home was built. Recommend installing arrester/rain cap for safety and to prevent moisture from entering chimney. Crack and/or deterioration were noted on the chimney in various areas on the cap and brick/mortar. Suggest a licensed qualified chimney contractor review and repair.

CONDITION: **No spark arrester/rain cap installed. These may not have been required when home was built. Recommend installing arrester/rain cap for safety and to prevent moisture from entering chimney. Crack and/or deterioration were noted on the chimney in various areas on the cap and brick/mortar. Suggest a licensed qualified chimney contractor review and repair.**

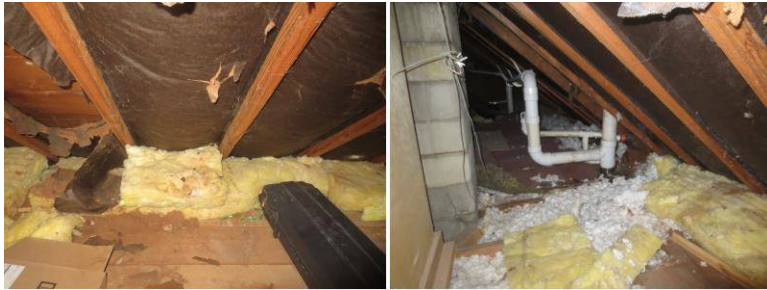
Improperly installed insulation noted. Insulating the attic roof/decking area is not recommended. Today's standards recommend insulating the attic floor and walls, which will help the attic space breath properly. If the attic ceiling is insulated there needs to be a proper air gap between the insulation and roof decking. Various areas of the insulation was damaged/loose. Suggest further review.

INSULATION CONDITION: **Improperly installed insulation noted. Insulating the attic roof/decking area is not recommended. Today's standards recommend insulating the attic floor and walls, which will help the attic space breath properly. If the attic ceiling is insulated there needs to be a proper air gap between the insulation and roof decking. Various areas of the insulation was damaged/loose. Suggest further review.**

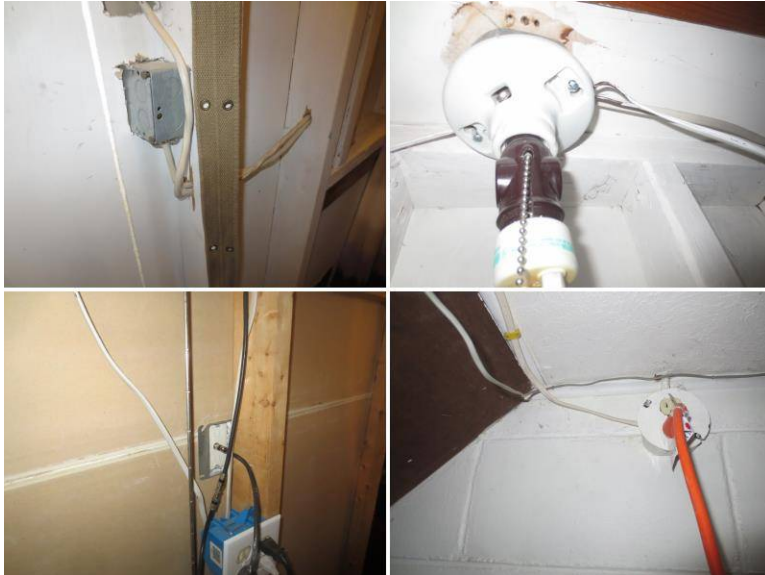
Exposed 110 volt electrical wiring noted in un-finished basement on the ceiling/walls in various areas. All exposed electrical wiring should be in an approved conduit for safety. Suggest further review/repair.

CONDITION: **Exposed 110 volt electrical wiring noted in un-finished basement on the ceiling/walls in various areas. All exposed electrical wiring should be in an approved conduit for safety. Suggest further review/repair.**

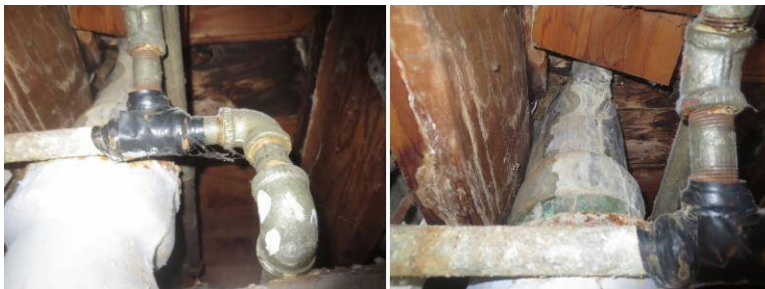
Black tape was wrapped around the waste line in basement utility room on ceiling-proper repairs are needed. Water leaking noted on old lead line under main floor hallway toilet. Suggest review/repair.

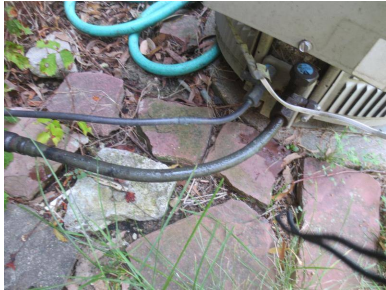
The outside 220 volt electrical wiring at the air conditioning unit is not in an approved electrical conduit. Suggest a qualified HVAC contractor review and/or repair.

POWER SOURCE: **The outside 220 volt electrical wiring at the air conditioning unit is not in an approved electrical conduit. Suggest a qualified HVAC contractor review and/or repair.**
